## Solution Proposals for Fires Occuring in the Laminatoin Units of Inline Lamination Machines

Hasan Uğur ÖNCEL<sup>1</sup>

, Emre RESULOĞLU<sup>2</sup>

<sup>1</sup>TC İstanbul Gedik Üniversitesi, Sağlık Bilimleri Fakültesi, 34906, İstanbul, Türkiye  
<sup>2</sup>TC İstanbul Gedik Üniversitesi, Lisansüstü Eğitim Enstitüsü, 34906, İstanbul, Türkiye

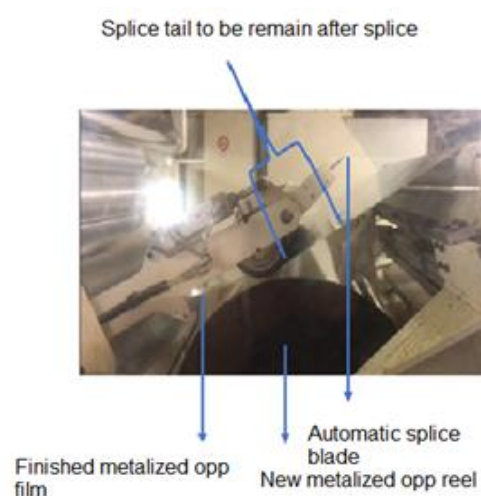
**Figure 1.** Automatic splicing unit

At a machine speed of 250 metres/minute, the splice tail reaches the lamination unit approximately 5 seconds after the automatic splice takes place. For reasons of food safety, the metallized surface of the metallized OPP should not come into contact with the food product, therefore the metallized surface is the one making with contact the adhesive cylinder to be coated with solvent-based adhesive before entering the drying tunnel. Fires were observed to occur synchronously with the entrance of the splice tail into the tunnel.

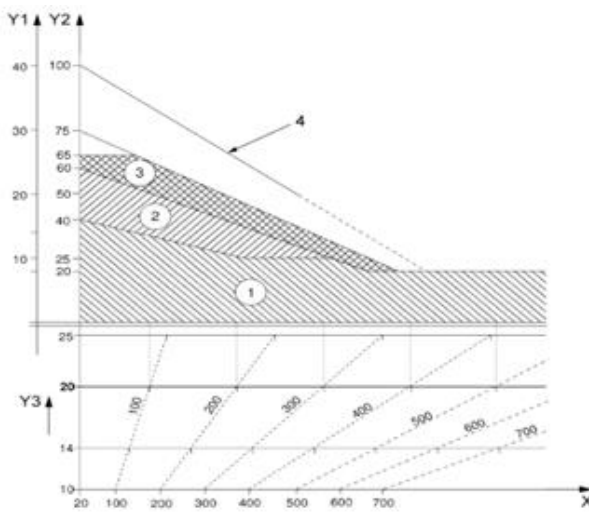
It must not be forgotten that, as the temperature in the dryer tunnel increases, the LEL% value at which ignition occurs decreases (Figure 5).

**Figure 5.** Maximum acceptable concentration and temperature values for inflammable substances

The chart above (Fig. 5) is taken from the BS EN 1539:2015 standard for the design of dryers and ovens operating with substances that produce highly flammable/flammable gases. As can be understood from the graph, as the temperature increases in the environment with solvent vapor, the LEL% value required for explosion/flammability decreases. Since the starting point of the graph is 20 °C and at this temperature a solvent at 100% LEL level can reach the ignition level, when there is a temperature increase to 100 °C, ignitions can occur at 80% measured LEL [7].

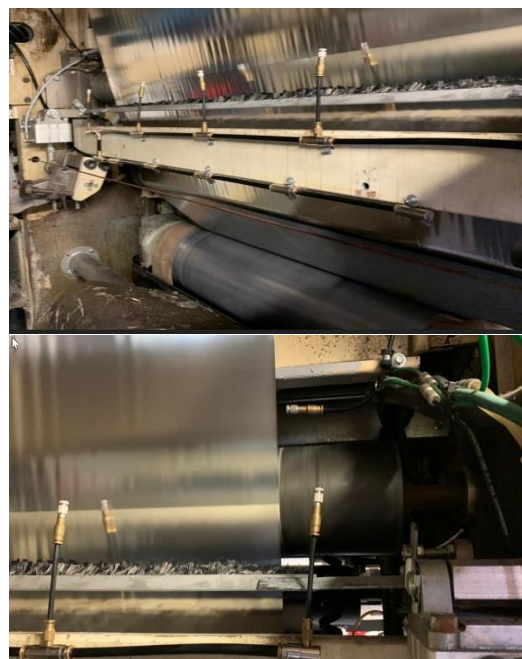
**Figure 7.** Dryer tunnel inlet pulverized water spray system.

In addition to the conditioning system installed in the production environment, an atomized water spray system was installed in the 11th unit at the entrance of the first drying tunnel. This helped prevent the remaining 10 cm tail part from fluctuating while at the same time the conductivity of the film surface was increased. In addition, the ethyl acetate concentration at the tunnel entrance was further reduced.

For the system, the pump has a water spraying capacity of 1 liter per minute, feeding water to 5x0.15mm spray nozzles at the point where the film comes out of the nip between the impression roller and the application cylinder. The water spray from these nozzles helps to ensure surface conductivity. A further 2x0.15mm nozzles spray water to act as a barrier between the tail and the main film at the time of entering the tunnel, with an additional set of 5x0.15mm nozzles, intended to reduce the ethyl acetate concentration, installed at the tunnel entrance.
